This monthly newsletter provides insight into construction activities and updates on the progress of the New Emergency Department project.

Month at a glance

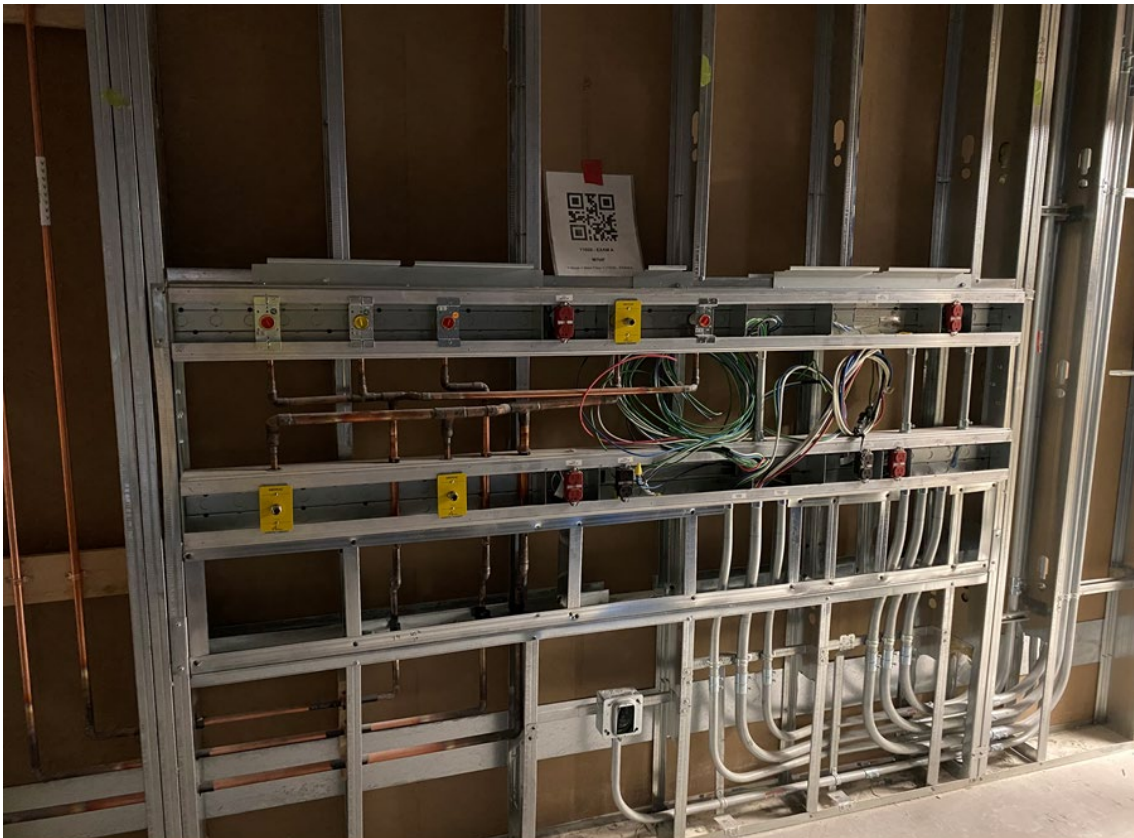
Headwall

A significant amount of planning and coordination is required for the installation of headwalls. Prior to receiving the headwalls, all mechanical and electrical piping and conduit was pre-bent and installed based on design coordination. These services then marry up perfectly to receive the headwall unit when it arrives. Services within the headwall are then pulled, terminated and tested.
